**REPORT ON THE RESTORATION OF THE PAINTING
“PRESENTACIÓN DE JESÚS EN EL TEMPLO”
 (“PRESENTATION OF JESUS IN THE TEMPLE”)**

| Object: | Painting. |

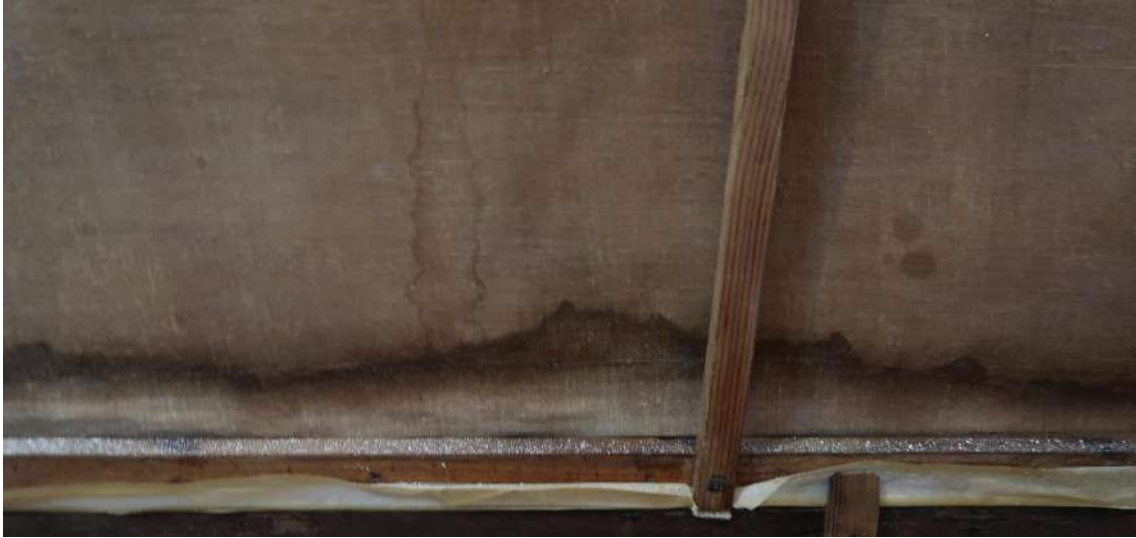
Detail of the back of the canvas showing where dust and detached fragments of wall paint have accumulated. These fragments retained moisture against the fabric for many years. In the image you can see marks caused by high levels of humidity.

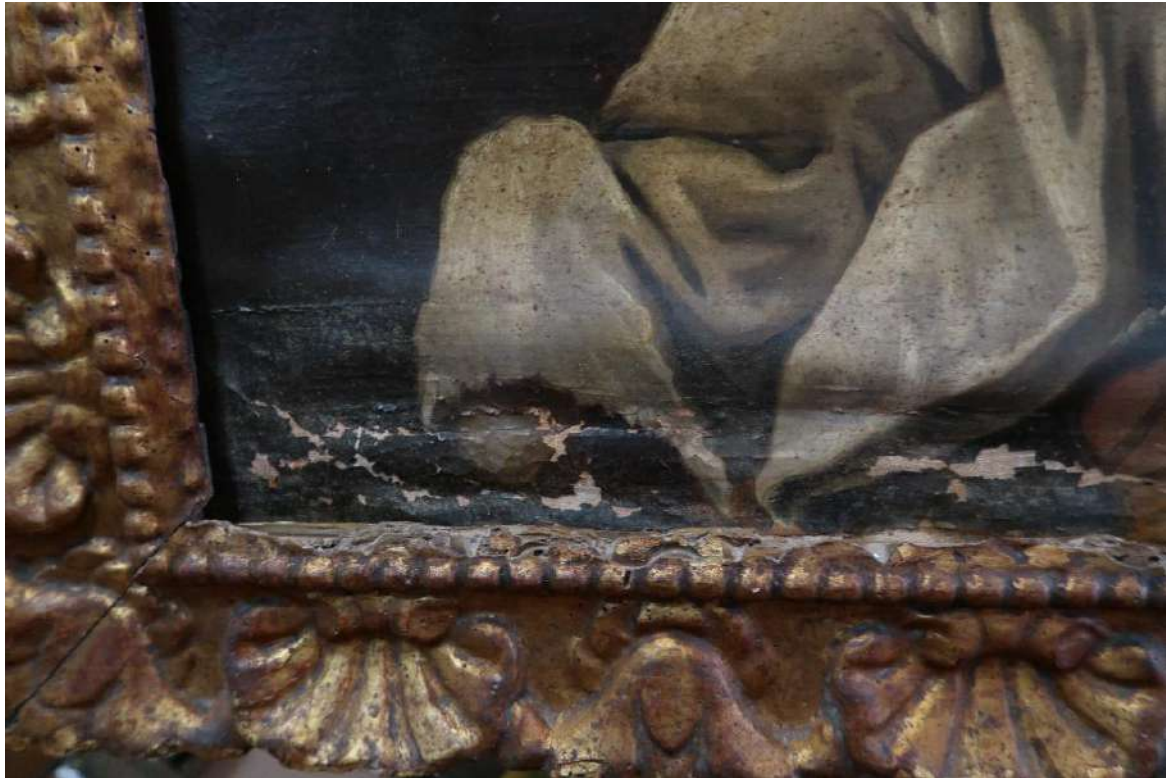
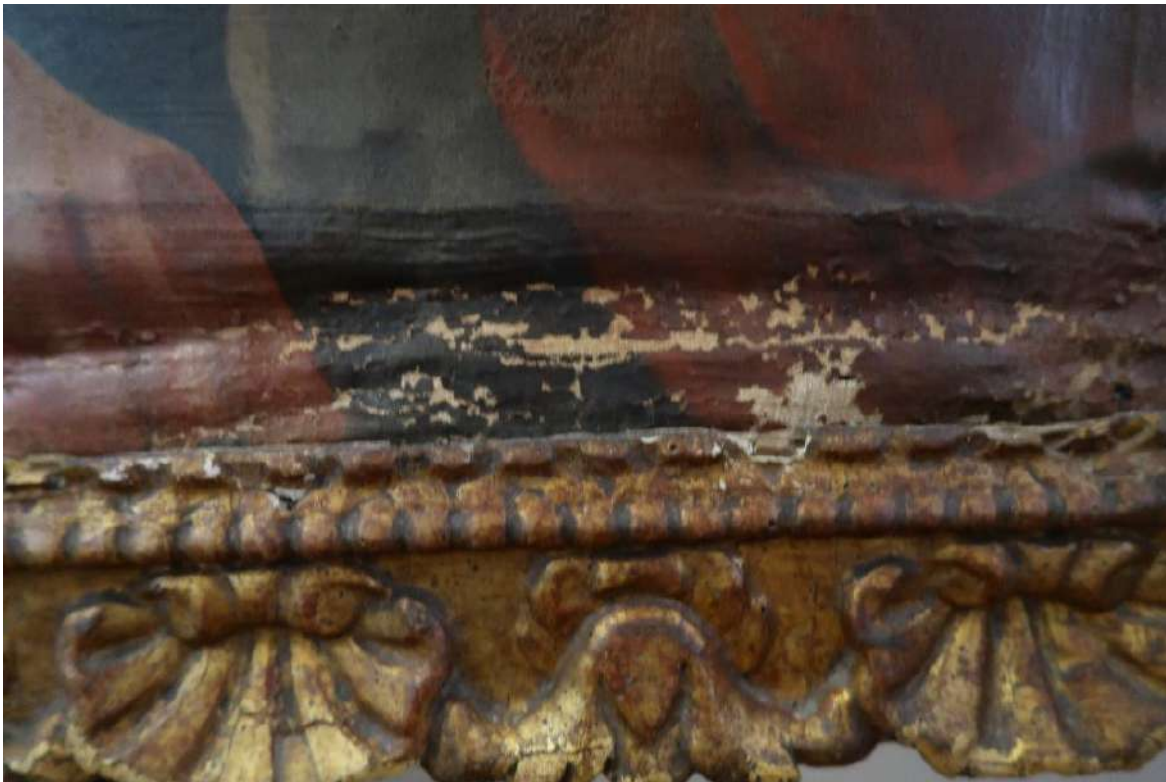
Details of the painting showing damage caused by moisture and dirt buildup on the frame.

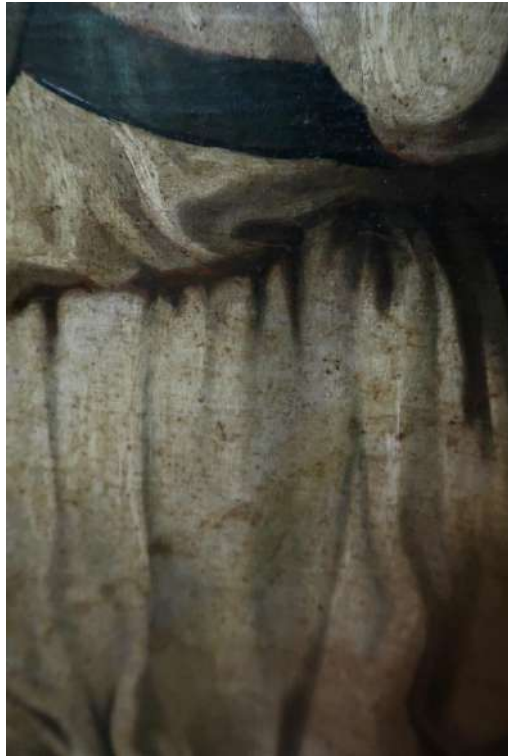
Detail showing dirt accumulated on the pictorial layer, along with the oxidised varnish giving it a yellowish appearance.
