**REPORT ON THE RESTORATION OF THE PAINTING
“RETRATO DE PEDRO MARTORELL Y OLIVES”
 (“PORTRAIT OF PEDRO MARTORELL Y OLIVES”)**

Object:	Painting.
Support:	Cloth.
Technique:	Oil.
Dimensions:	101 x 81 cm.
Description:	Portrait of Mr. Pedro Martorell y Olives. The portrait displays three-quarters of a seated figure. His title, decorations and dates of birth and death are annotated to the right. Below this you can see what looks like a shield representing his family.
Period:	19 th Century (1863).
Author:	J. Portusado.
Property:	Carlos de Salort Sintes. Palau Salort.
Previous Restoration:	Betancourt Workshop 1999/2000.

Start of restoration: December 2022
Completion of restoration: February 2023

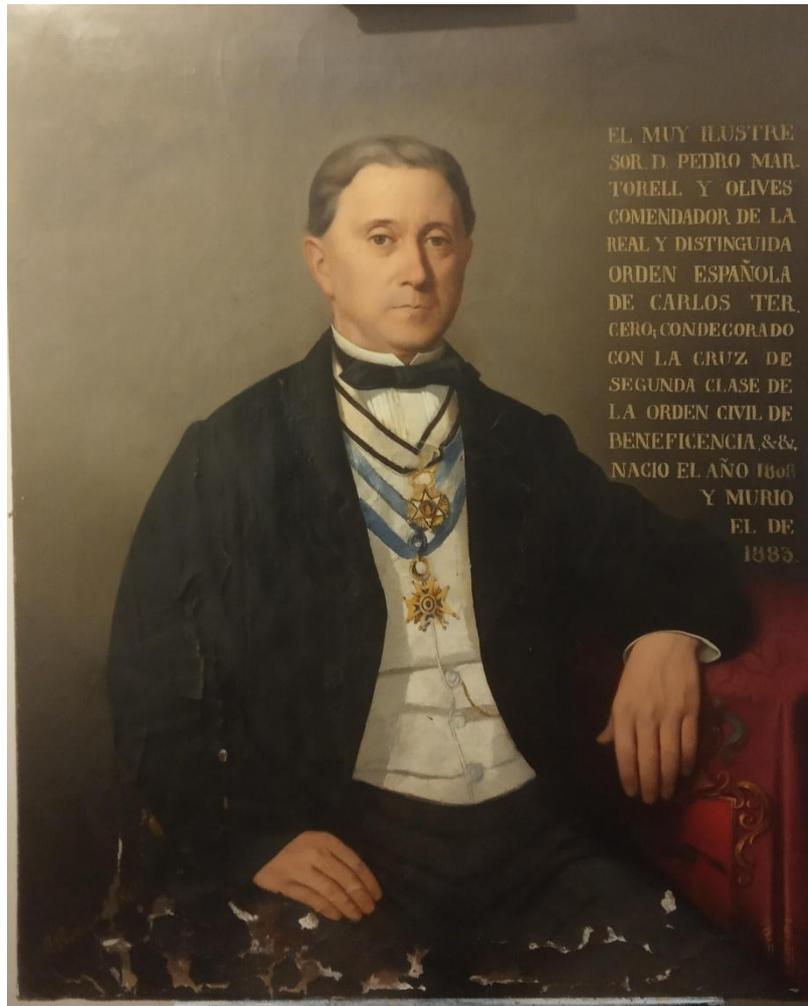
Image prior to restoration.

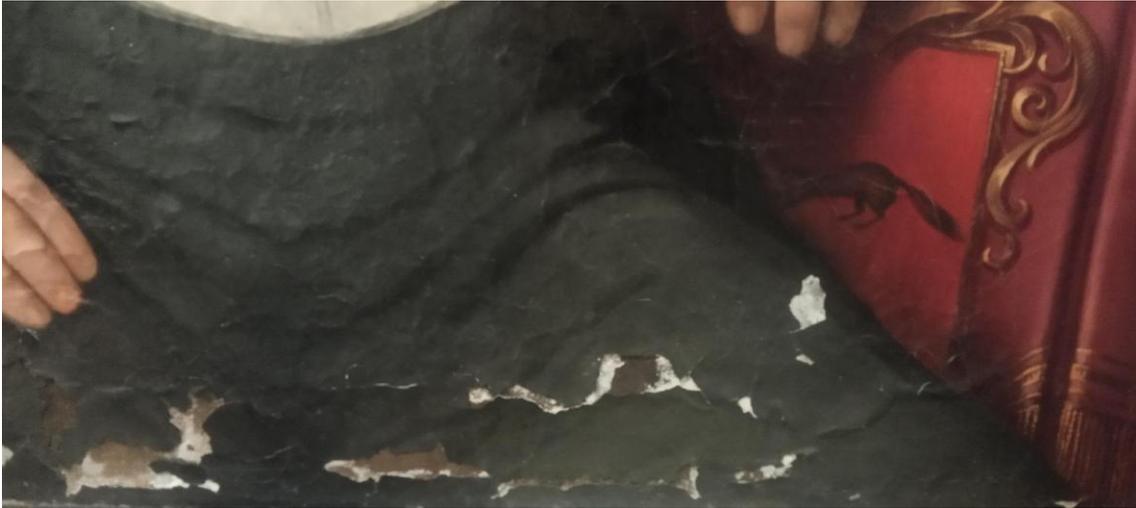
Detail of the lower right area of the painting, where losses to the paint layer can be observed. The detail of the shield can also be appreciated.

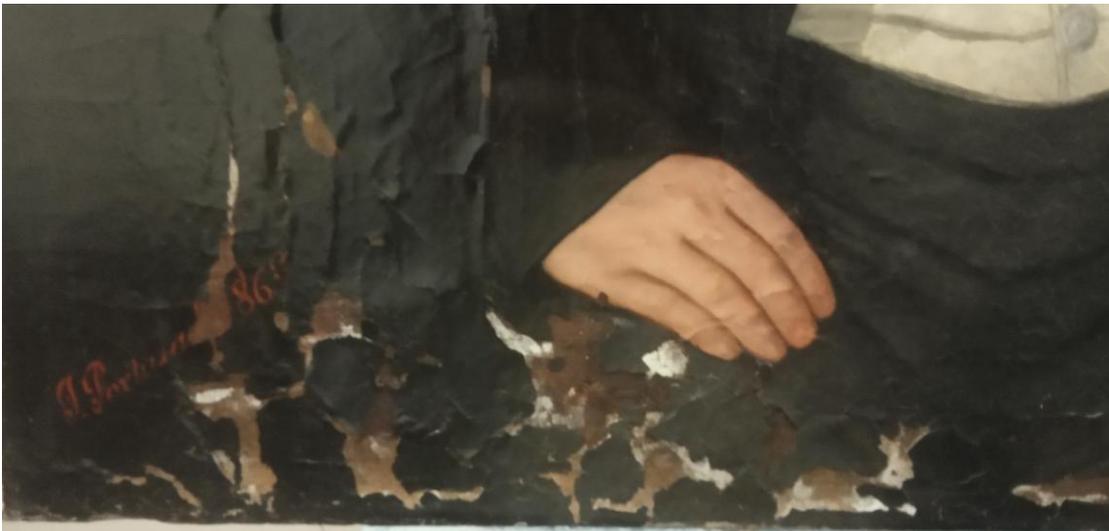
- In the upper and middle part of the central figure, the paint layer presented significant cracking, causing areas to lift. This was more than likely caused by the aging of materials and the effects of fluctuations in temperature and humidity over time.
- In the lower part of the painting there were significant losses of the paint and preparation layer and what remained of the paint layer was in a very delicate state. This had occurred in areas that had been previously treated. Therefore, in addition to the causes described above, other factors have contributed to the delamination, such as the materials used during previous treatment or the thickness of the gesso used to fill the gaps that existed at that time.

Detail of the lower left area, where losses were more significant.

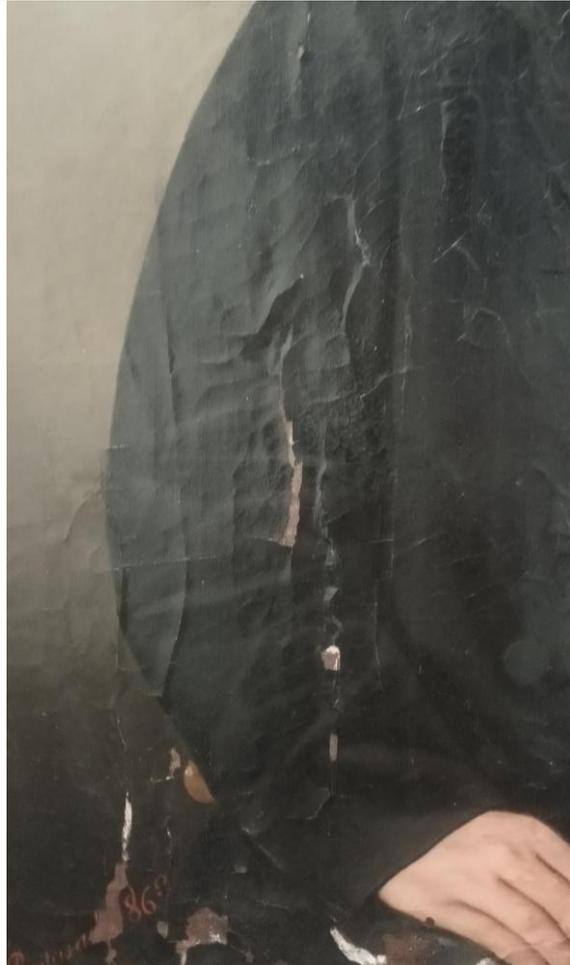
Detail of one of the areas where cracks were more prominent in the paint layer which had increased the risk of loss.

The treatment used to remedy this problem was fixation with resins applied with a hot spatula. This procedure was used to treat both the delamination from the support and small deformations that had occurred in the fabric. Once the entire surface had been treated, the canvas was cleaned, removing the existing varnish and the remains of the resin. As an intermediate layer, before the gesso, a layer of retouching varnish was applied with a palette. Next, the losses of the paint and preparation layer were filled with gesso and retouched.

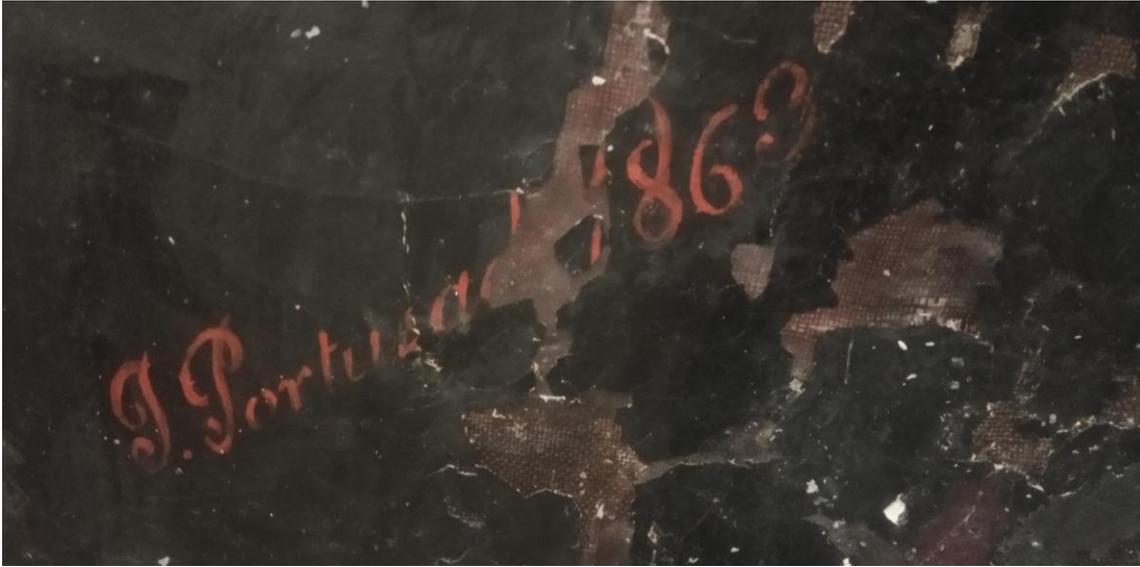
Detail of the artist's signature. This area had suffered significant losses to the paint layer. When it came to retouching, the option used was to apply the background tone, without reproducing the strokes and thus not compromising the artist's signature.

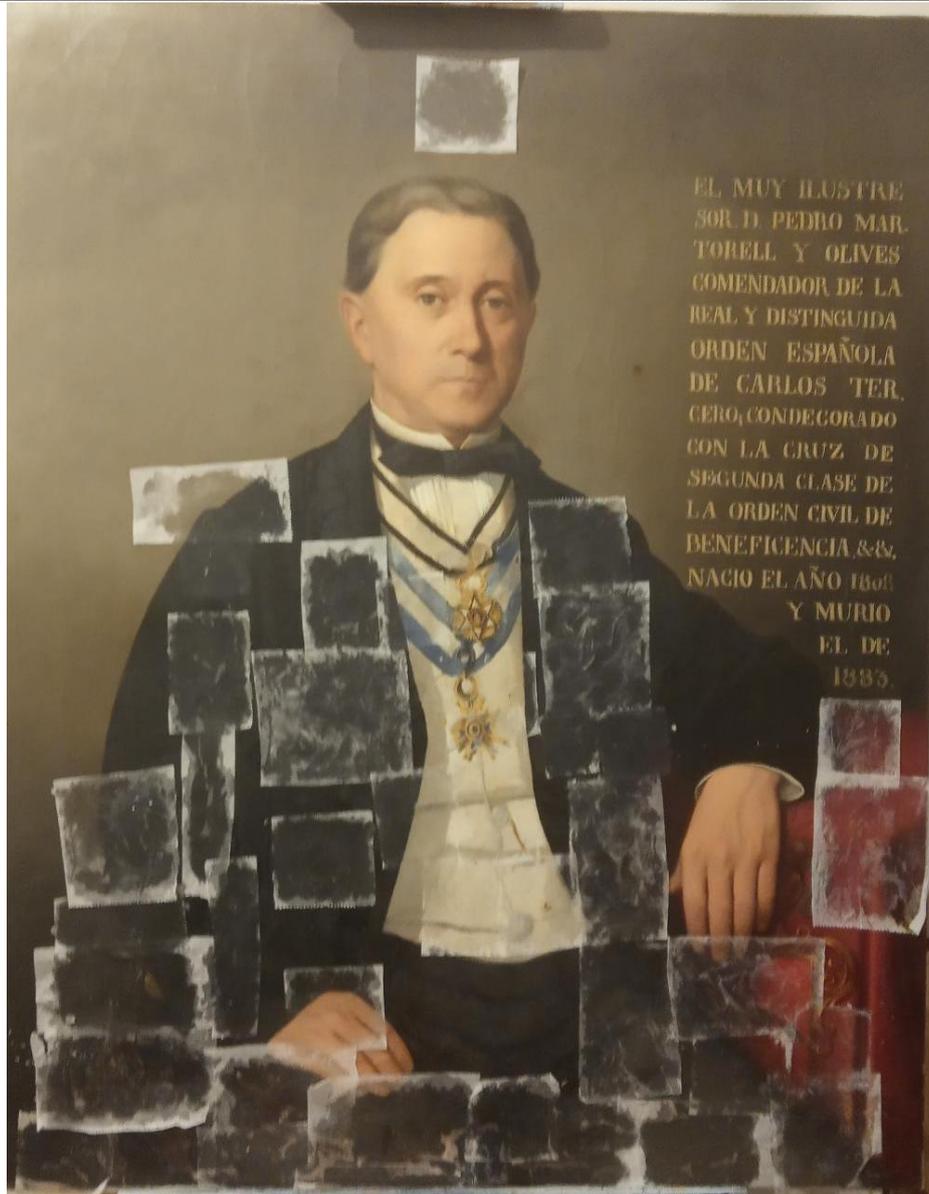
Image of the treatment process, you can see the protective papers used to apply the resin with a hot spatula without damaging the paint layer.

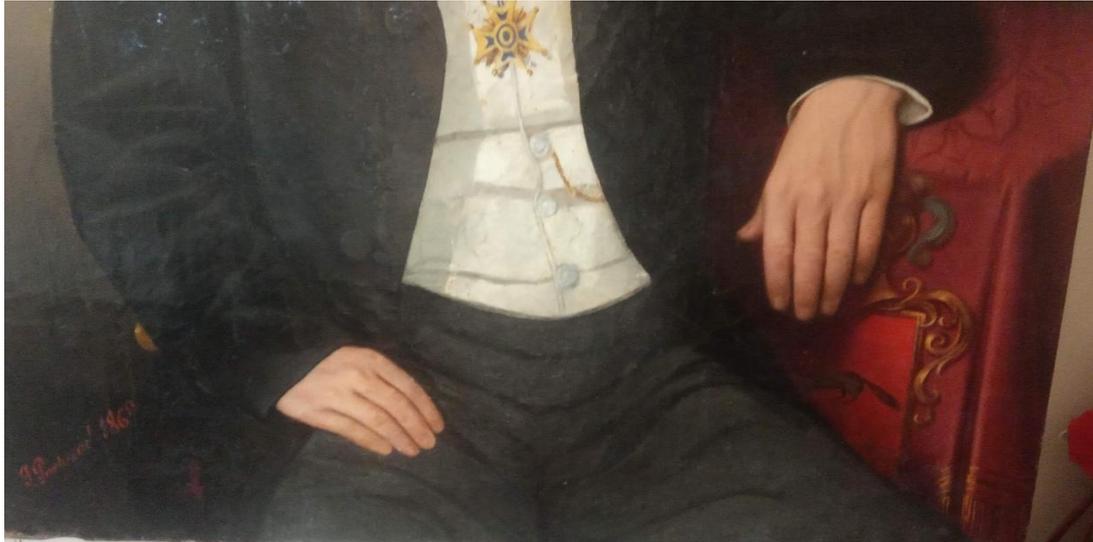
Detail of the area following retouching where the losses were most significant.

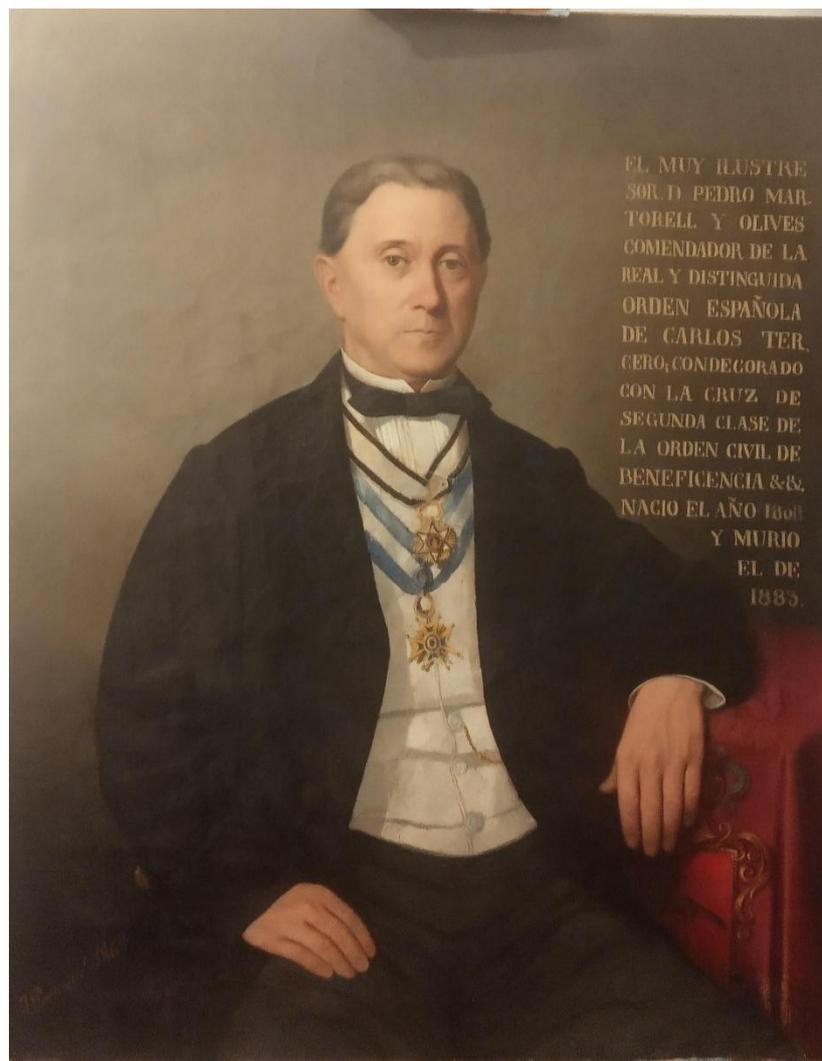
Final image.

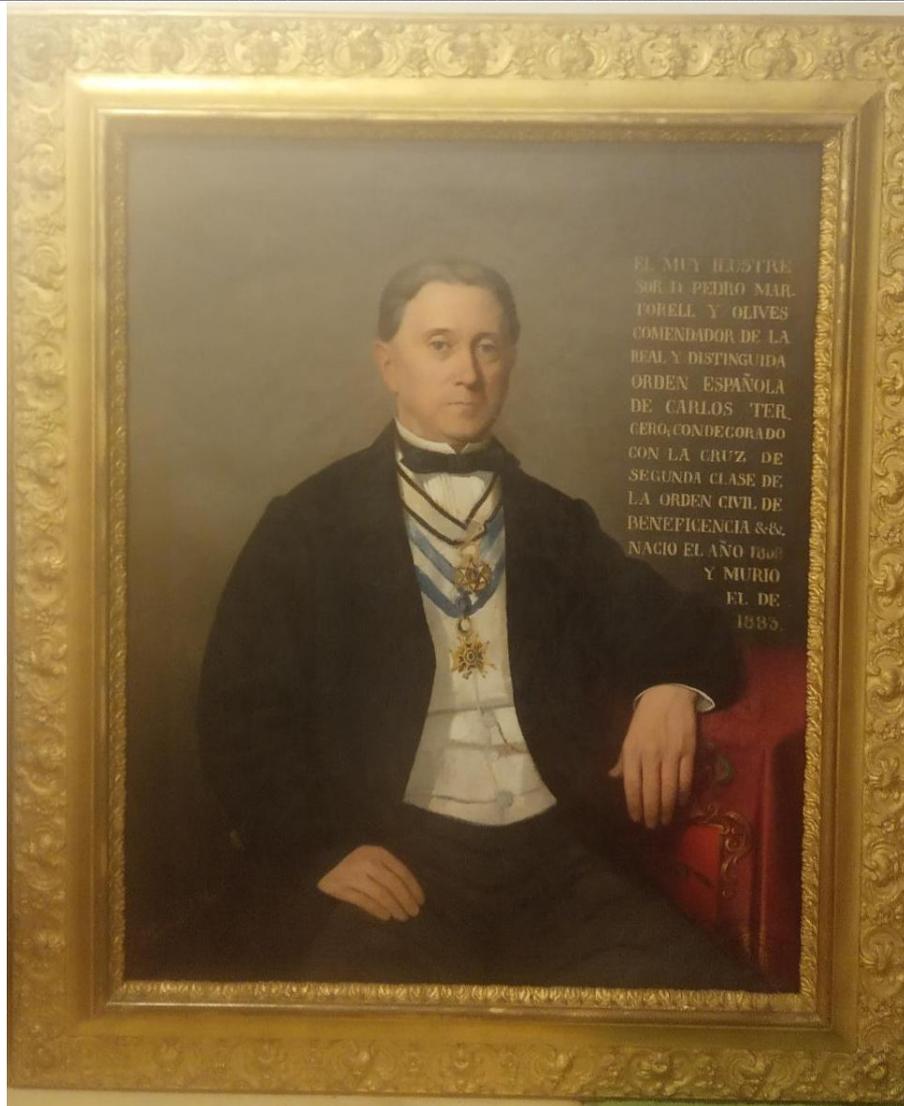
Painting returned to frame. The rear anchors to attach the frame to the frame were replaced, thus improving the hold and avoiding rust of the nails that were previously used.
